TECHNICAL REPORT REMR-CO-3

CASE HISTORIES OF CORPS BREAKWATER  
AND JETTY STRUCTURES

PACIFIC OCEAN DIVISION

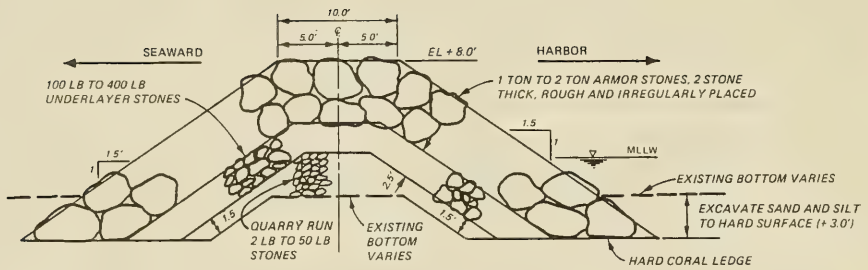
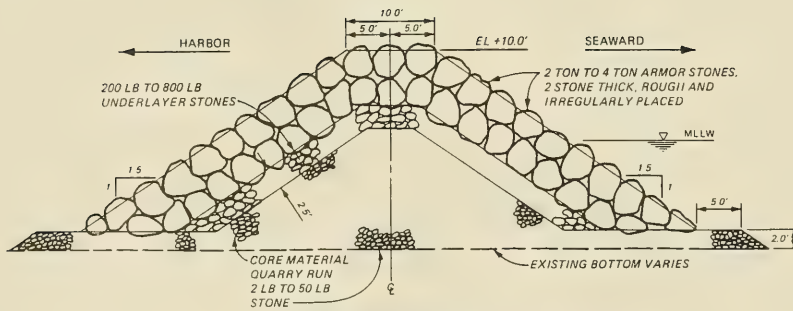
Date(s)	Construction and Rehabilitation History
1975	The 80-ft-long west and 110-ft-long east breakwaters were added to the existing project at a cost of approximately \$150,000 (Figure 1). The armor stone on the east and west breakwaters (Figure 2) was designed for 6- and 4-ft nonbreaking waves, respectively.
1978	The head of the west breakwater was rebuilt. Failure of the original head was thought to be due to the original structure toes not being placed on a firm foundation, thereby resulting in undermining of the toe and slippage of the armor stone layer. The head was rebuilt with the same size armor stone; but the sand was excavated, and the toe was placed on a firm coral bottom.
1984	Inspection of the stub breakwaters in July revealed that both structures were in good condition.

Figure 2. Typical breakwater cross sections, Haleiwa Harbor, Oahu, Hawaii

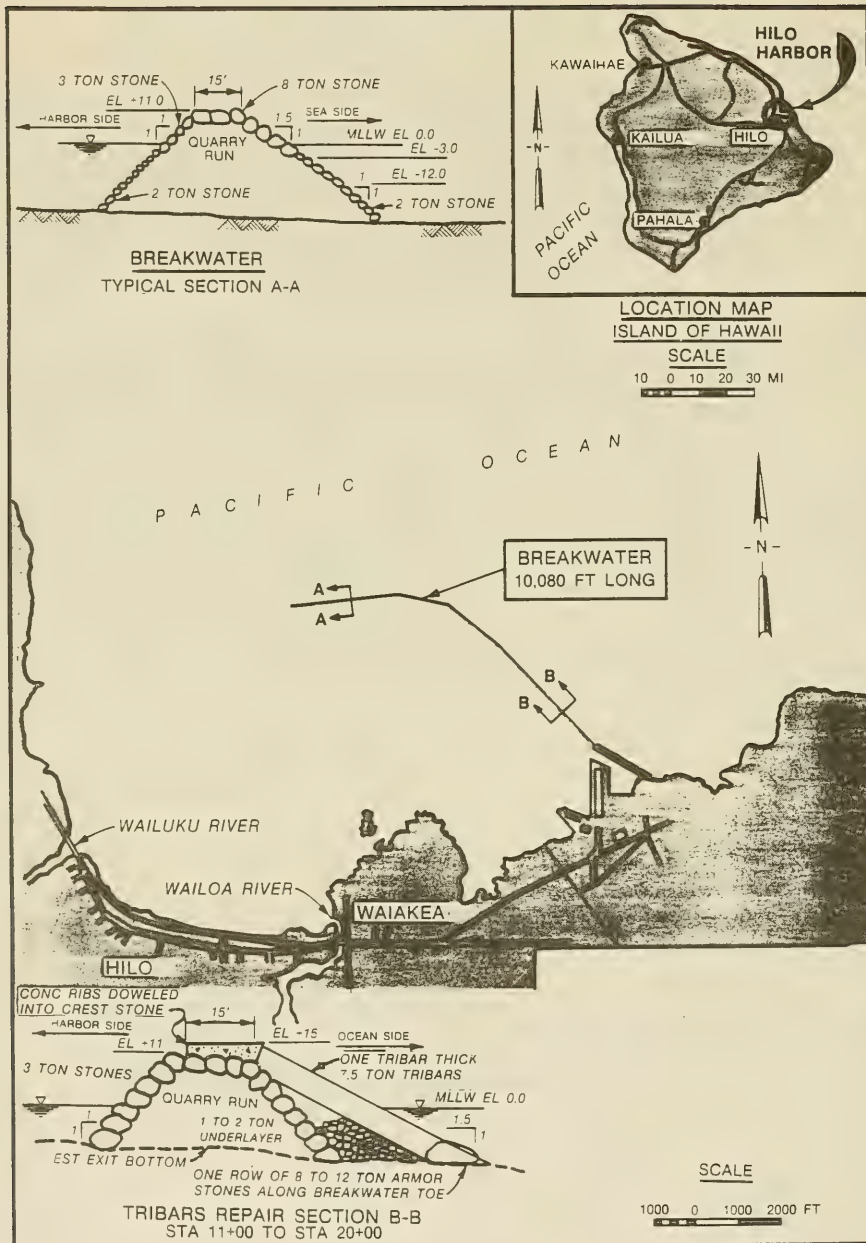
Figure 3. Hilo Harbor, Hawaii, Hawaii

Date(s)	Construction and Rehabilitation History
1930	The Corps completed the 10,080-ft-long rubble-mound breakwater (Section A-A, Figure 3).
1931- 1945	Only minor repairs were required to restore the original construction at an average annual cost of \$10,000 based on 1967 money.
1946	The tsunami of 1 April severely damaged 6,000 ft of the breakwater. Primary armor stone and core material were displaced both seaward and toward the harbor down to an average elevation of -3.0 ft mllw. A 1,100-ft-long breach occurred adjacent to the piers.
1946- 1948	Tsunami damage was repaired using original design criteria at a total cost of \$1,500,000.
1949- 1952	Storm waves of December 1951 caused damage to 13 areas (Figure 4). By October 1952 the structure had been repaired to the original cross section at a cost of \$76,000.
1954- 1957	Storm waves of March 1954 caused damage to several areas (Figure 4). By August 1957 the structure had been repaired to its original cross section at a cost of \$80,000. The structure was exposed to the tsunami of 9 March 1957 but sustained no damage.

1960	The tsunami of 1960 caused breakwater damage (Figure 4), but it was not as severe as that sustained by the 1946 tsunami. Less severe damage was attributed to the direction of wave attack. The 1960 approach was less direct than that of 1946; therefore, wave energy reaching the structure was less than what had occurred in 1946. Between 1946 and 1960 average annual maintenance costs were \$25,000. It was thought that the 1946-1948 repair work did not key the replacement armor into the existing structure, thus resulting in weaker cross sections in these repair areas.
1965	Storm waves of February 1965 caused additional damage at sta 15+00, 36+30, 73+40, 83+00, and 90+00.
1967	Between the 1960 and the 1967 tsunami, no repair work was done due to the possibility of total rebuilding of the breakwater as one leg of a proposed tsunami barrier for Hilo Harbor. The average annual cost of structure maintenance had been \$43,900 for the first 37 years of the project.

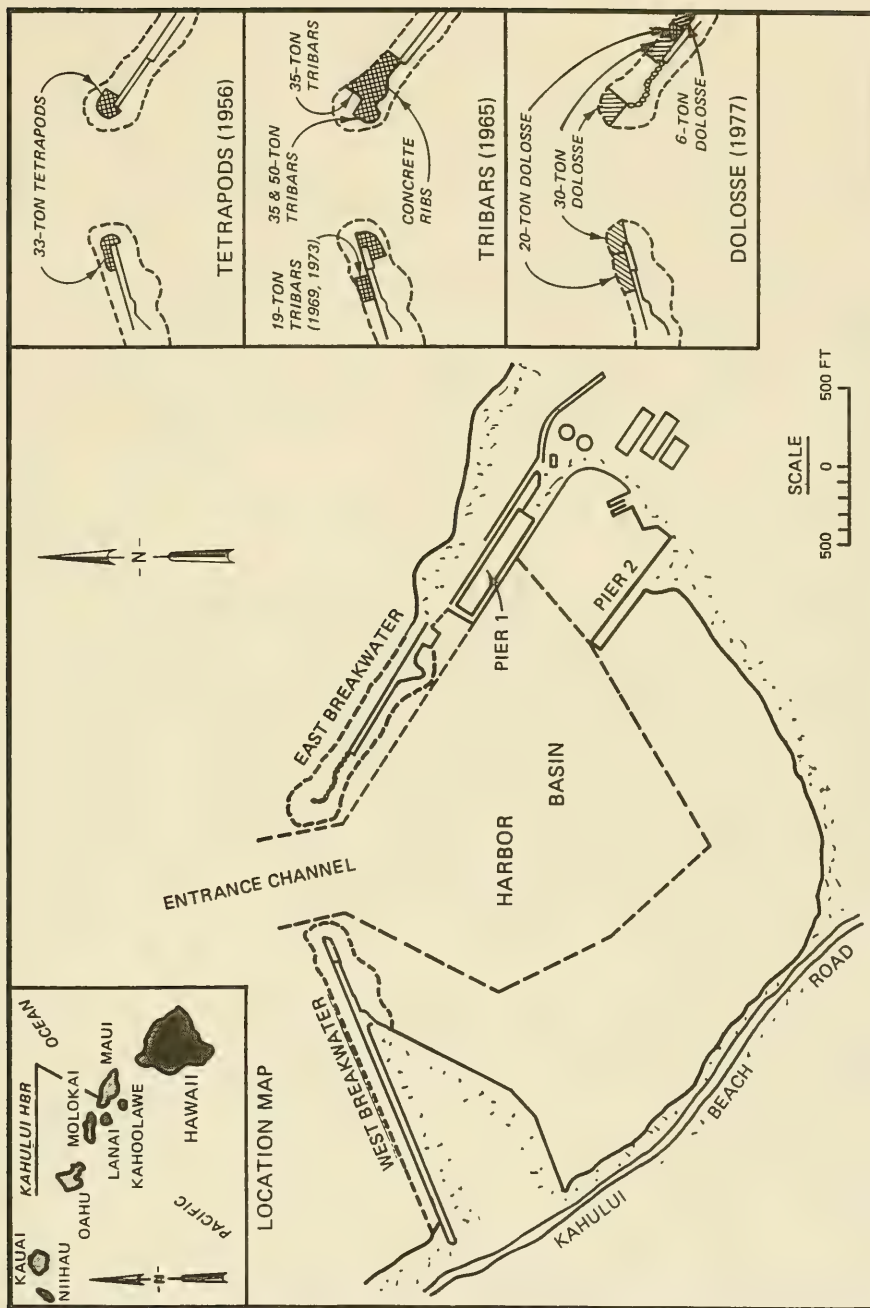
Figure 5. Kahului Harbor, Maui, Hawaii

Date(s)	Construction and Rehabilitation History
1900	The Kahului Railroad Company constructed the original harbor which consisted of a berthing area, a dredged channel, and a 400-ft-long east breakwater (Figure 5, location map).
1913	The first breakwater improvements constructed by the Corps of Engineers were completed (Figure 6). These improvements included a 400-ft-long extension of the east breakwater.
1919	The Corps constructed the west breakwater to a length of 1,950 ft.
1931	Extensions of the east and west breakwaters to lengths of 2,766 ft and 2,315 ft, respectively, were completed.
1931- 1954	Maintenance costs exceeded \$1,000,000. Routine maintenance and repair involved approximate restoration of damaged breakwater sections to their original conditions.

On 14-17 October 1943 the east breakwater was damaged. Approximately 45 tons of rock on the extreme east end were dislodged and washed into the inner harbor area. Approximately 150 ft shoreward of the east breakwater light a larger mass of stone was dislodged and washed into the harbor. This break was on the inside of the east breakwater and covered an area approximately 75 ft long and 20 ft deep. The Estimated repair quantity was 250 tons.

1956	<p>Repairs of damage caused by the March 1954 storm were completed (Figures 5 and 7). Head repairs consisted of a double layer of 33-ton unreinforced tetrapods on a 1-V:3-H seaward slope and a 1-V:2-H landward slope. Two layers of tetrapods also were extended 250 ft down the sea side of the west breakwater trunk, and the core of both was capped with 2 ft of concrete.</p> <p>A total of 400 tetrapods was placed. To prevent encroachment of the structures on the entrance channel, the breakwaters were shortened slightly, and a 1-V:2-H slope was used on the inboard quadrant of the armor wraparound on the breakwater heads. The total cost of repairs was \$1,200,000.</p>

1977	<p>A 1973 breakwater inspection indicated considerable damage and settlement of the 33-ton tetrapods on the seaward quadrants of both breakwater heads. In addition, the 8-ton armor stone along both trunks was failing and required repair. In 1977 the following repairs were completed (Figure 5): on the west breakwater, 257 30-ton reinforced dolosse were placed in two layers over the 33-ton tetrapods on the sea-side quadrant of the head; 291 20-ton reinforced dolosse were placed on the sea-side slope of the west breakwater trunk; on the east breakwater 610 30-ton reinforced dolosse were placed in two layers over the 33-ton tetrapods on the sea-side quadrant of the head; 164 20-ton reinforced dolosse were placed in a double layer on the sea-side slope of the trunk beginning at the shoreward end of the 35-ton tribars; and, beginning at the point where the 20-ton dolos ended and extending shoreward, two layers of 6-ton unreinforced dolosse (455 units) were placed on the sea-side slope of the east breakwater trunk. The total cost was \$3,290,000.</p>

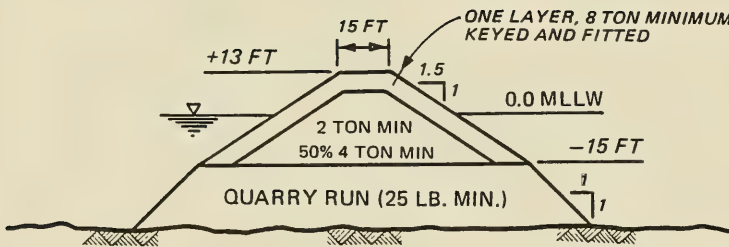
Figure 6. Kahului breakwater construction of 1913  
(typical cross section)

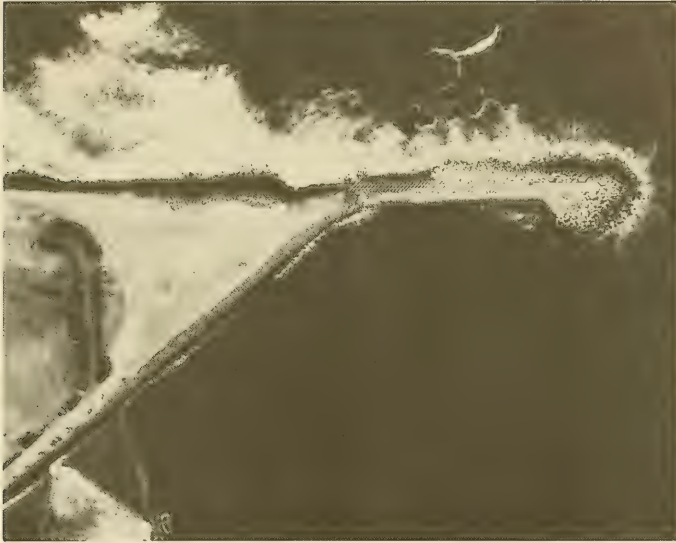
<u>Date(s)</u>	<u>Construction and Rehabilitation History</u>
1984 (cont.)	were buttressed with 25-ton tribars. On the east breakwater one layer of 9-ton tribars was placed harborside between sta 23+80 and sta 27+15; also, from sta 19+50 to sta 23+80, one layer of 9-ton tribars was placed on the harborside, and a concrete rib cap was constructed (head at sta 27+66). A total of 540 6.5-ton, 755 9-ton, and 10 25-ton tribars was placed. In Figure 11(a,b) are aerial photographs of the east and west breakwaters taken in January. The estimated cost of repairs was \$6,000,000.

Figure 11. Aerial photographs of the Kahului breakwater, 1984

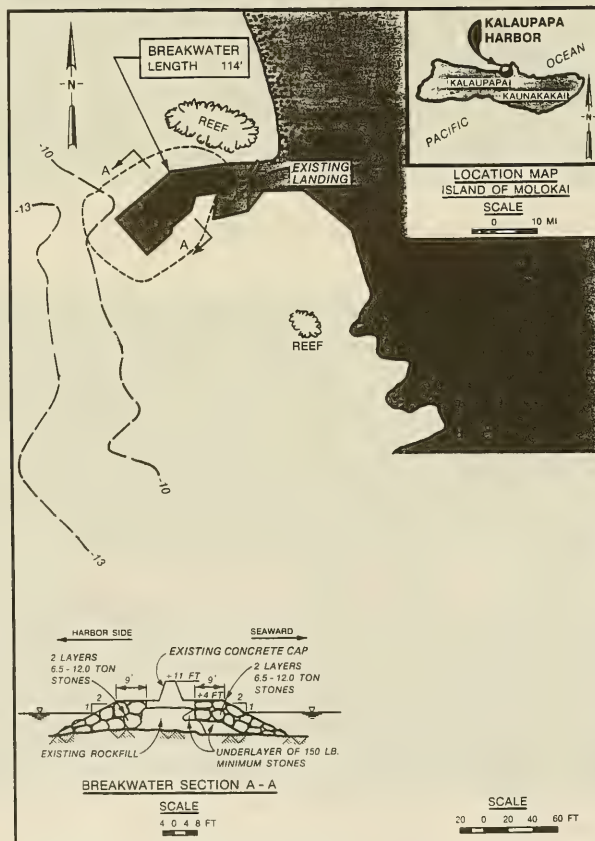
Figure 12. Kalaupapa Harbor, Molokai, Hawaii

Date(s)	Construction and Rehabilitation History
1967	<p>An existing rock fill breakwater with a concrete cap was improved by widening the crown and armoring the structure slopes with 6.5- to 12-ton armor stone (Figure 12). The armor stone was designed for a 12-ft breaking wave in a water depth of 15 ft at the breakwater head. The breakwater modification cost approximately \$95,000. As of 1984, the structure has required no major maintenance.</p>

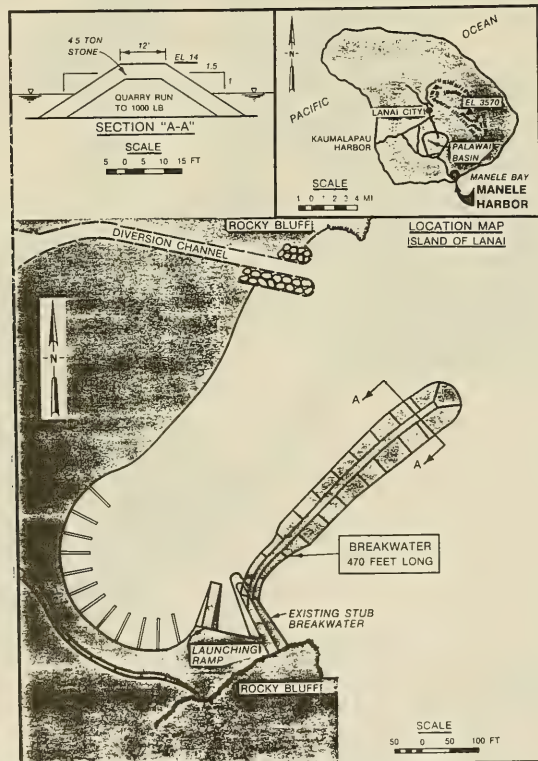
Figure 14. Manele Small-Boat Harbor, Lanai, Hawaii

<u>Date(s)</u>	<u>Construction and Rehabilitation History</u>
1965	A 470-ft armor stone breakwater extension was added to an existing stub breakwater. The breakwater was part of a light draft harbor project completed in 1965 (Figure 14). Total project cost was \$742,850. Along the breakwater's length the armor stone varied from 2 to 4.5 tons for design breaking-wave height ranging from 3 ft at the root to 10.1 ft at the head.
1984	Recent inspection of the breakwater revealed only minor damage that did not warrant immediate attention.

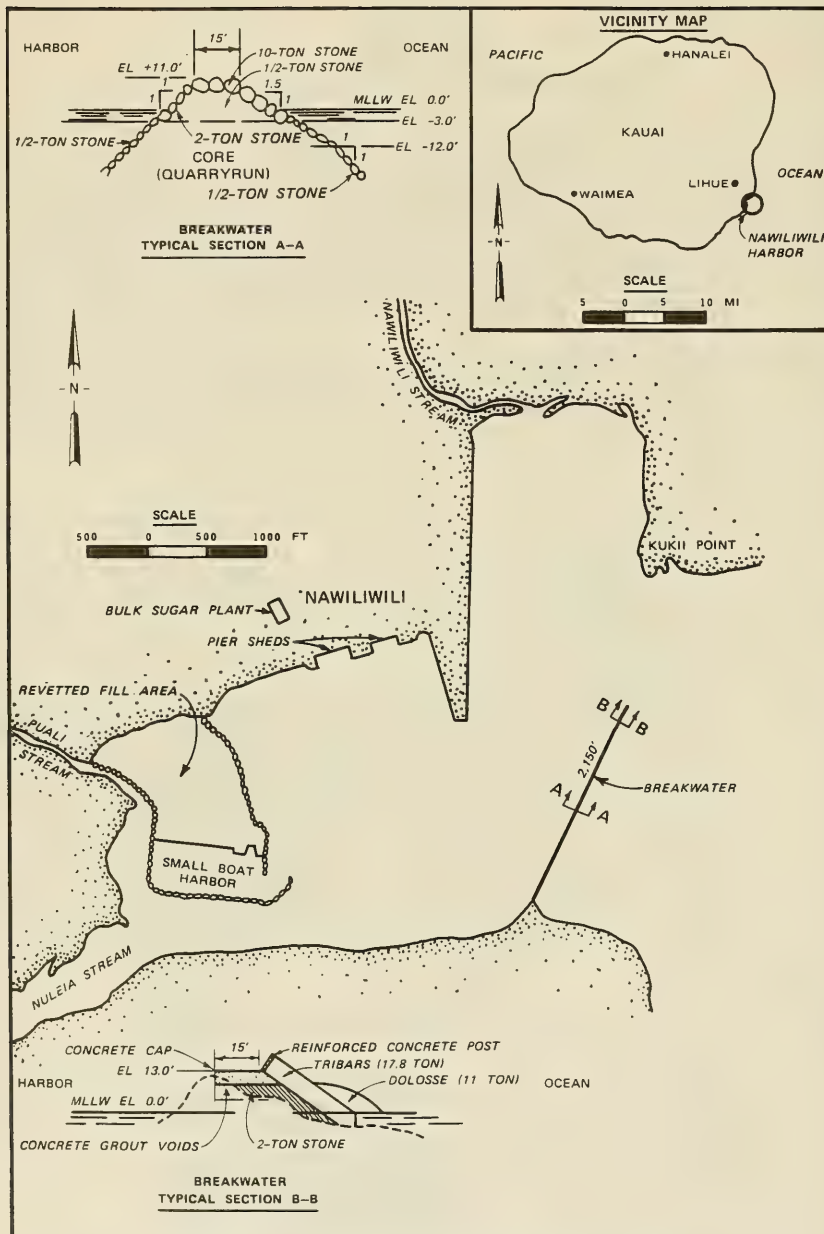
Figure 15. Nawiliwili Harbor, Kauai, Hawaii

Date(s)	Construction and Rehabilitation History
1926	The original Corps-constructed (Figure 15) 2,150-ft-long rubble-mound breakwater was completed (construction started in 1922). It consisted of one-layer 8-ton keyed and fitted armor stone over core stone (500 lb and less) with 1-V:1-H slopes and a 15-ft-wide crown at +11.0 ft mllw. Except for severe wave action, it was considered to be a satisfactory empirical design cross section.
1927- 1953	Minor repair work was done at various times during this period. In 1931 114 stones were reset, and 3,153 tons of stone and concrete blocks were placed (no details available) at a cost of \$46,040. In 1930, 1932-37, 1945, 1951, and 1952, 1,998 tons of stone were used in repair work at a total cost of \$78,285. Details of the repair work were not found.
1954- 1957	The breakwater was severely damaged as the result of a storm in 1954 (hindcasted depth-limited breaking wave height of 24 ft at structure) which destroyed the head, washed 100 ft of core stone shoreward, and settled capstone to an elevation of a few feet below mllw with little lateral movement. Storm waves displaced armor stone and exposed and removed core material between sta 17+50 and sta 20+45 in 1956. Observed wave heights of 16 ft at the breakwater in September 1957 caused additional armor stones and core displacement between sta 16+00 and 20+45 and displacement of a few armor stone and core exposure between sta 14+00 and sta 16+00. Hydrographic and topographic surveys of January 1958 revealed that Hurricane Nina (depth-limited breaking waves at structure on 1 and 2 December 1957) displaced a few armor stones and exposed core material on the sea-side slope between sta 14+00 and sta 15+00. It also caused settling and raveling of all armor stone on the crown and sea-side slope between sta 15+00 and sta 20+20, resulting in an exposed core and large voids between armor stones and all armor stone and core above mllw (sta 19+25 to sta 19+50 and sta 20+20 to sta 20+45) which was displaced shoreward.

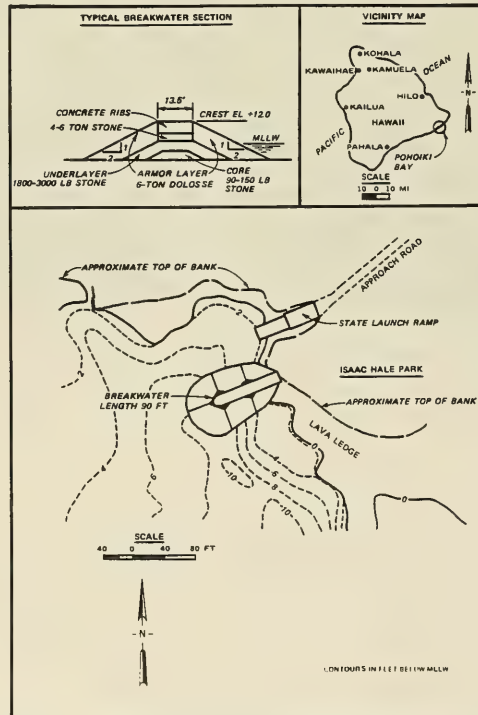
Figure 19. Pohoiki breakwater, Hawaii, Hawaii

A 90-ft dolos-armored structure with a concrete rib cap was constructed in 1979 at a cost of approximately \$335,500 (Figure 19). The structure was designed for 12-ft depth-limited breaking waves at the structure. The wave condition has reportedly occurred on several occasions since completion of construction, and the structure shows no signs of deterioration. The 6-ton unreinforced dolosse (two layers) exceeded the needed weight for the design conditions but were found to be more economical than a lighter weight in that fewer units were needed. All existing dolosse breakage (5 units) occurred during construction and were left on the structure. Figure 20 is an aerial photograph of the breakwater taken in 1984.

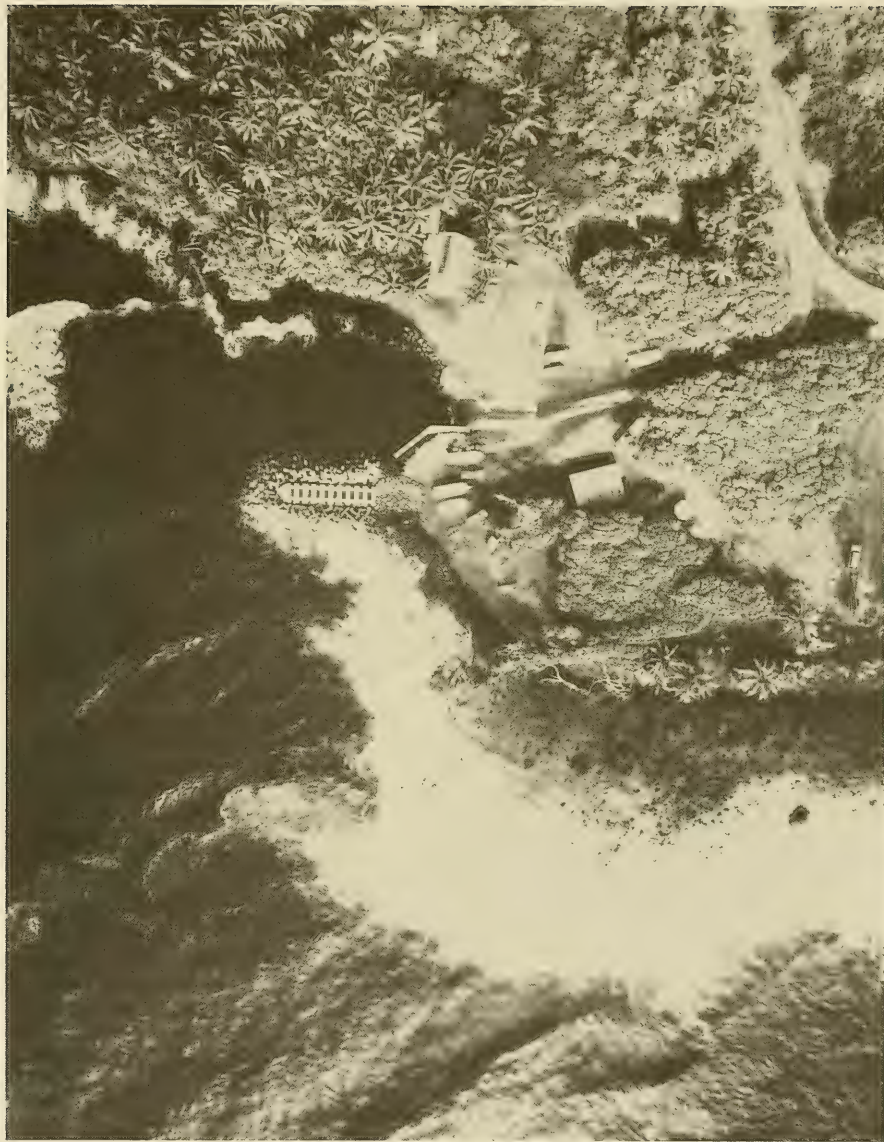
Figure 20. Pohoiki breakwater, 1984

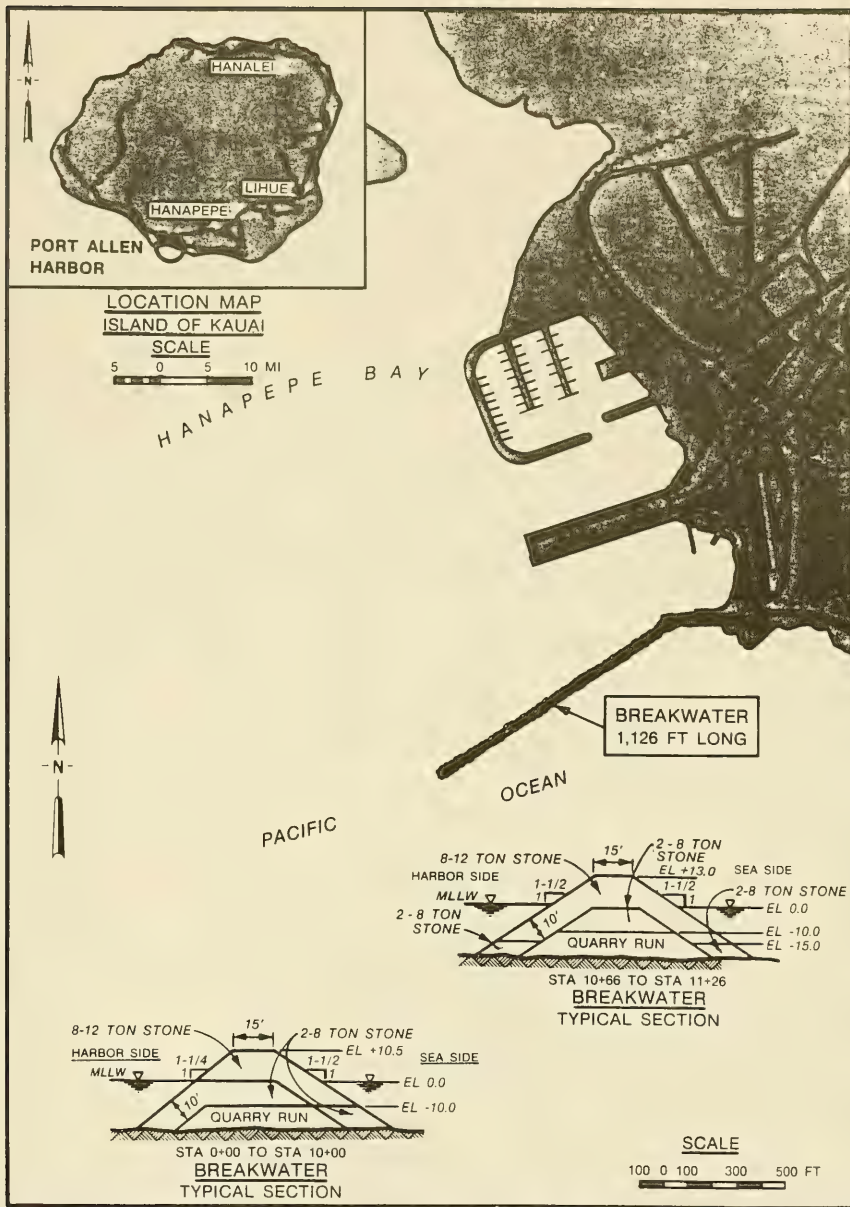
Figure 21. Port Allen Harbor, Kauai, Hawaii

<u>Date(s)</u>	<u>Construction and Rehabilitation History</u>
1935	The 1,200-ft-long structure was completed as an extension to a privately constructed breakwater (Figure 21).
1982	Until damaged by Hurricane Iwa of November 23, the old 8-ton keyed-and-fitted armor stone structure had no repair history. The breakwater light at the seaward end had been damaged and repaired several times (Coast Guard cost) prior to its present destruction. The estimated 20-ft breaking waves at the structure first dislodged the stones on the inboard crest which eventually resulted in the total destruction of the outer 130 ft of the breakwater. Overtopping waves also displaced crest stone and exposed under-layer stone on a 150-ft length at the extreme root of the structure. Minor damage also was sustained along the inboard slope.
1984	The head was rebuilt, and the minor damage on the inboard slope was repaired at a cost of \$178,000. The breakwater was shortened to a total length of 1,126 ft. The outer 74 ft was abandoned. The repair was accomplished by resetting stone remaining on the structure and by retrieving stone from the harbor and replacing it on the structure using the old keyed-and-fitted construction (Figure 22). The crown elevation on the last 80 ft of structure was increased to +13.0-ft mllw. This was done to improve the stability of the inboard slope by decreasing wave overtopping. The root of the breakwater was not repaired.

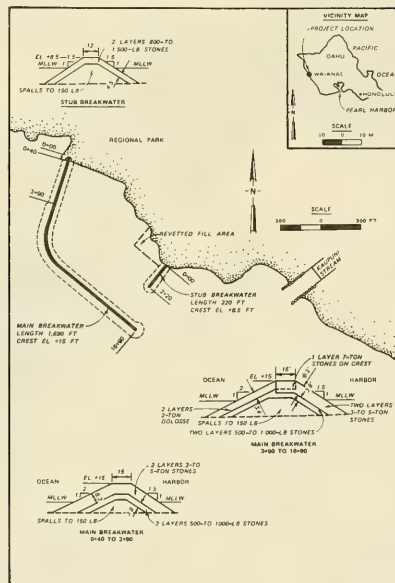
Figure 23. Waianae Small-Boat Harbor, Oahu, Hawaii

Date(s)	Construction and Rehabilitation History
1979	The 1,690-ft-long armor stone and dolosse-armored main breakwater and 220-ft-long armor stone stub breakwater were completed in January (Figure 23). The dolosse-armored portion of the main breakwater was model tested (Bottin, Chatham, and Carver 1976) for a design breaking wave height of 11.8 ft in a water depth of 16 ft.
1980	Inspection of the structure revealed that 203 of the 6,633 dolosse originally placed were broken. It is estimated that 47 of these were broken and left in place during construction.
1982	Inspection subsequent to Hurricane Iwa of November 23 revealed no additional breakage of dolosse, but it is thought that a section of dolosse around sta 4+00 may have slumped slightly.
1984	The structures looked in good condition during a 7 August 1984 inspection. Dolos breakage appeared unchanged from 1980, and the slump area referred to above did not appear to pose any immediate problem. There was no obvious need to implement breakwater repair.

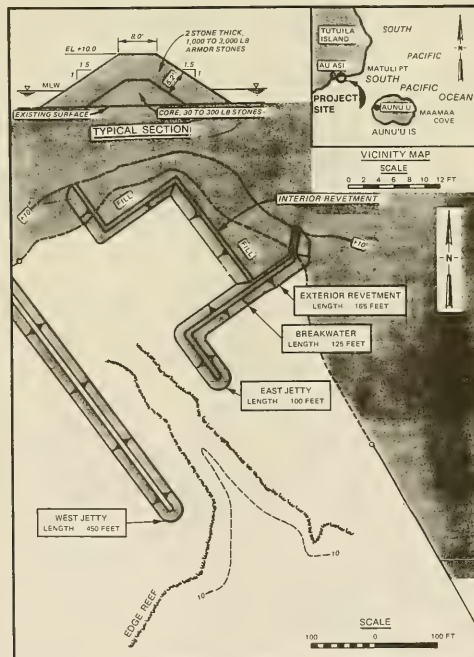
Figure 24. Auasi Small-Boat Harbor, Tutuila Island, American Samoa

Date(s)	Construction and Rehabilitation History
1981	<p>A 125-ft armor stone breakwater and 100- and 450-ft east and west armor stone jetties, respectively, comprised a portion of the project completed in 1981 (Figure 24). Total cost of the project was approximately \$1,166,300. The structures were designed for depth-limited breaking wave heights of 4.8, 7.0, 5.6, and 6.0 ft for the breakwater, west jetty head, west jetty trunk, and entire east jetty, respectively. Water depths for these wave heights were 6.2, 7.2, 7.2, and 7.7 ft, respectively. The structures have no history of damage or repair. There is some evidence of armor stone breakage. Although quarried basalt armor stone appeared to be free of cracks when placed, internal stresses may be responsible for breakage. Testing by dropping from a 10-ft height onto a stone bed did not result in breakage during construction. The condition is not widespread and is not considered serious at present.</p>
